CONSERVATION TREATMENT FINAL REPORT

MOUNT OLIVE CEMETERY

Jackson State University
Jackson, Hinds County, Mississippi

February 21, 2024

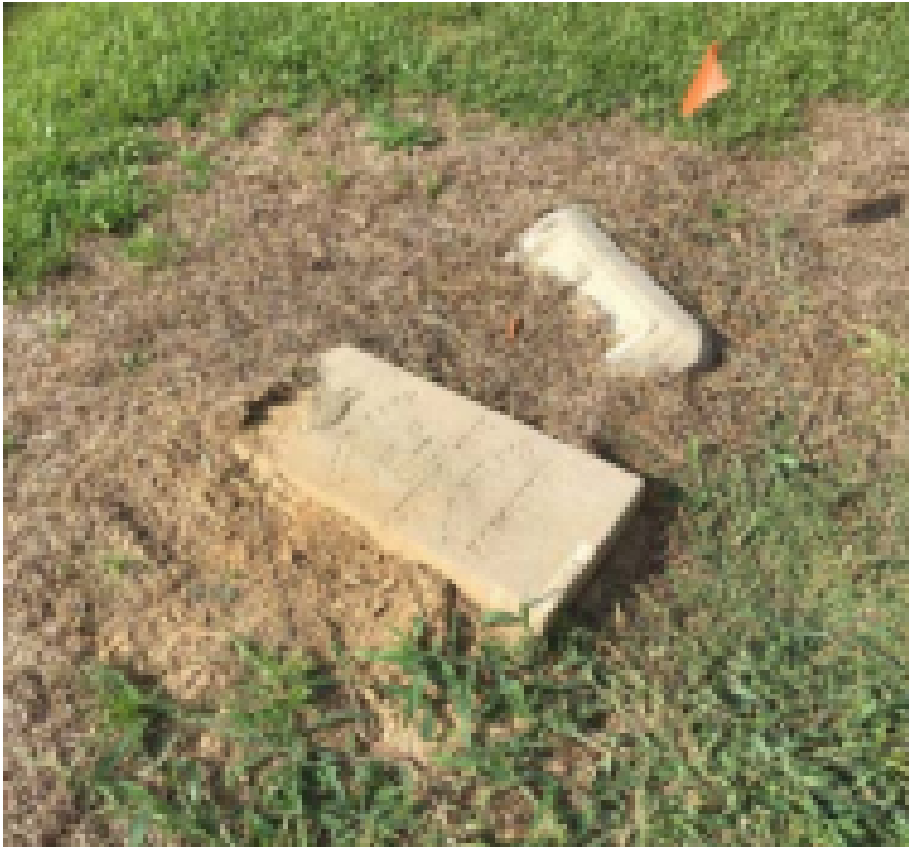
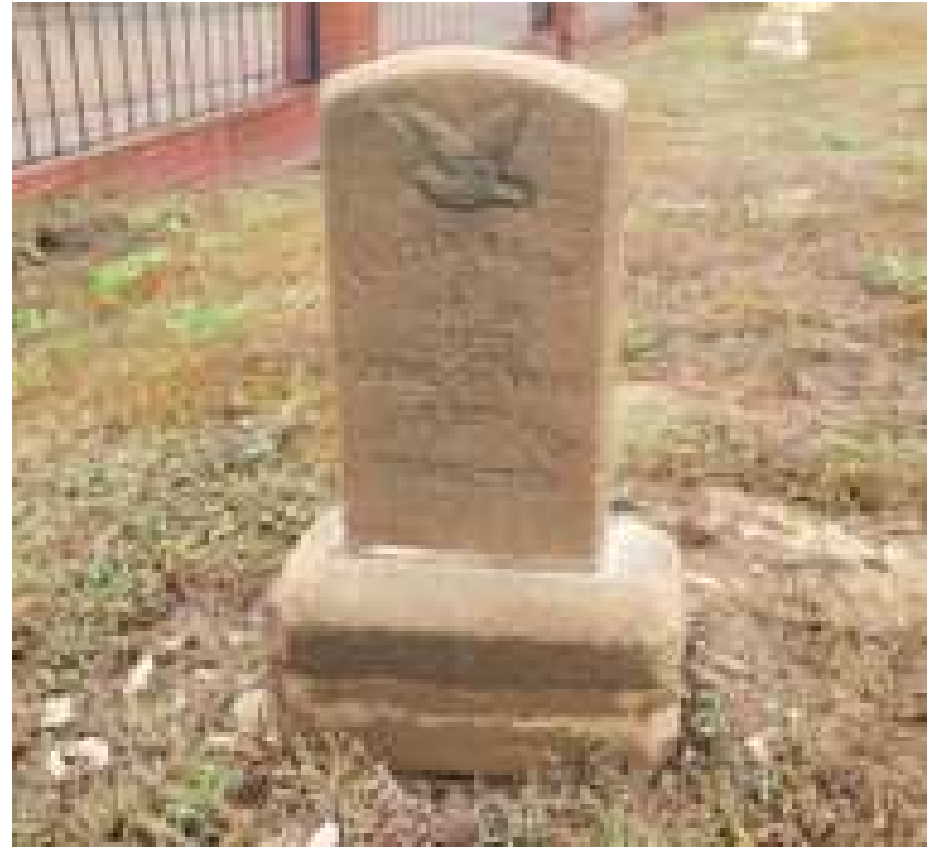
Conservation Treatment for Lizzie Back

After excavating the concrete die and base by digging a shallow trench at each elevation, RGA determined that the base was broken into two pieces. The broken pieces of the base were joined using small dabs of the epoxy-bonding agent Akemi Akepox stone structural epoxy.

RGA's conservation team leveled the socketed base with a mixture of crushed rock and sand. Resetting/leveling this base involves setting it on a compacted bed of crushed rock and sand, backfilling, and tamping the crushed rock and sand, and replacing and tamping the topsoil removed during excavation. The use of crushed rock and sand for leveling is preferential to concrete because concrete is much harder than the original stone type, and the mixture of crushed rock and sand helps maintain drainage away from the gravemarker.

RGA cleaned the die and base with no psi water and a soft, wet brush. Conservation work included the cleaning/treating of both the die and socketed base with Orvus WA Paste (a non-ionic detergent) and D/2 Biological Solution to remove atmospheric staining and biological growth, respectively.

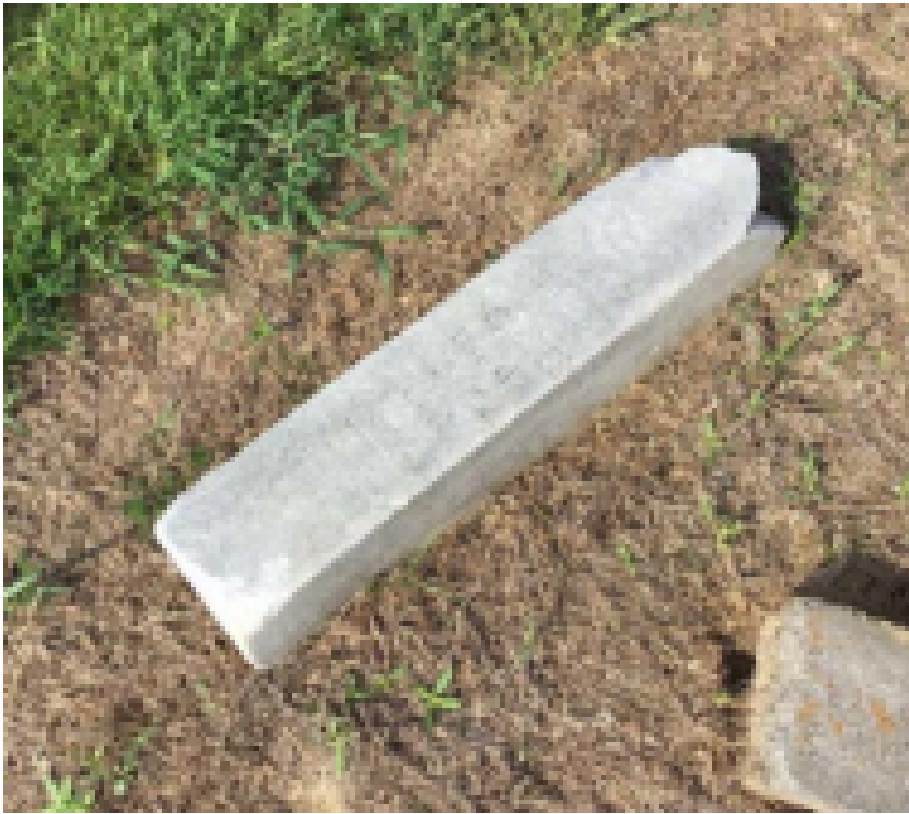
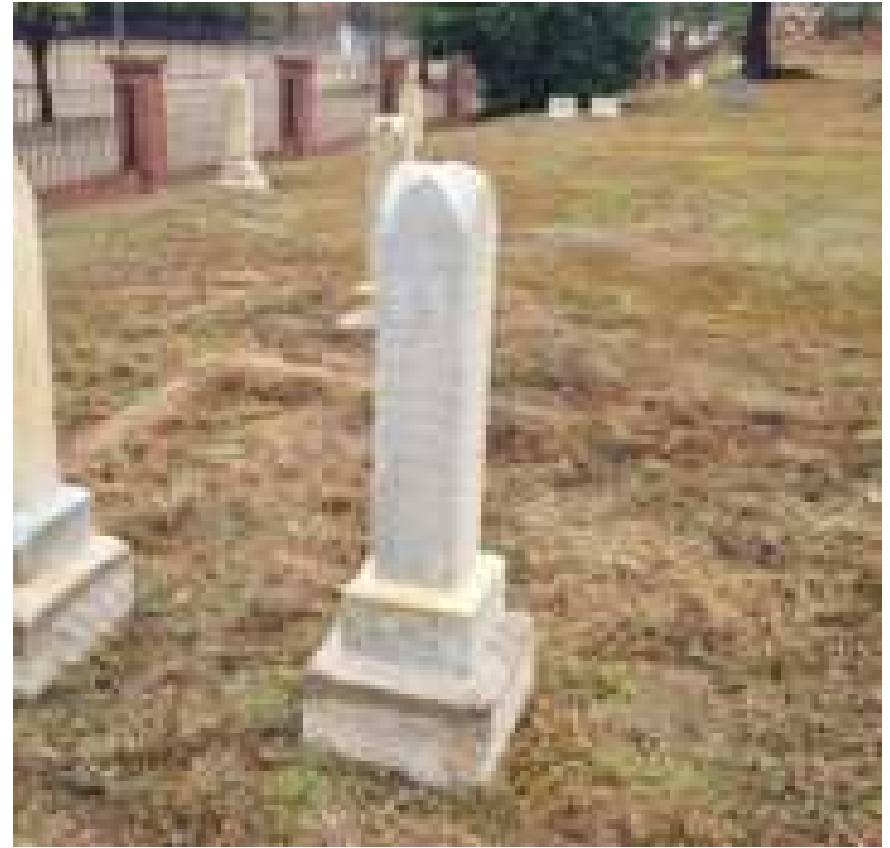
Conservation Treatment for Mary McCarter

Degraded, failed structural mortar was removed with small hand tools such as stone and wood chisels and metal mallets. The shaft and stacked bases were joined using lead wedges placed in each corner, small dabs of the epoxy-bonding agent Akemi Akepox stone structural epoxy, and Limeworks.us Ecologic Natural Hydraulic Lime 3.5 (NHL), non-pigmented repair mortar.

RGA cleaned this marble pedestal tomb and stacked bases with no psi water and a soft, wet brush. Conservation work included the cleaning/treating all components with Orvus WA Paste (a non-ionic detergent) and D/2 Biological Solution to remove atmospheric staining and biological growth, respectively.

RGA's conservation team relocated the stacked bases and shaft to area adjacent to the burial plot and place them on padded supports where they can be properly assessed and cleaned. The lowest base was leveled on a mixture of crushed rock and sand. Resetting/leveling requires excavating to the bottom of the gravemarker, straightening the base to vertical, backfilling and tamping the crushed rock and sand, and replacing and tamping the topsoil removed during excavation. The use of crushed rock and sand for leveling is preferential to concrete because concrete is much harder than the original stone type, and the mixture of crushed rock and sand helps maintain drainage away from the gravemarker.

Each component (stacked bases and shaft) was lifted using a wood clamp system operated by two people.

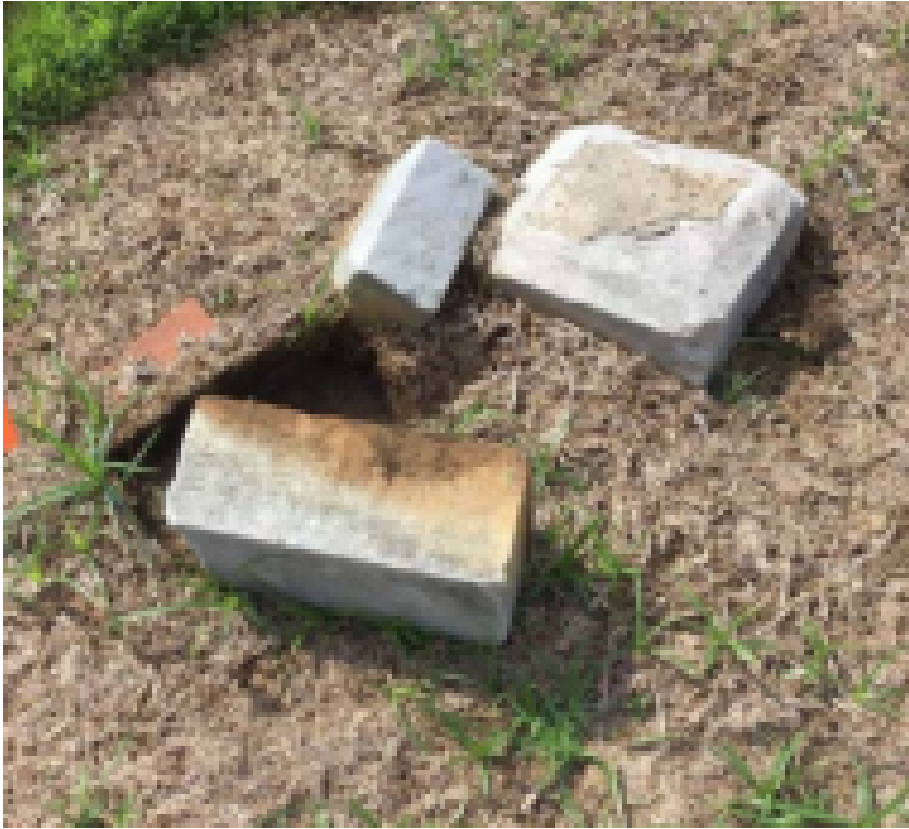
Conservation Treatment for Philip McCarter

Degraded, failed structural mortar was removed with small hand tools such as stone and wood chisels and metal mallets. The shaft and stacked bases were joined using lead wedges placed in each corner, small dabs of the epoxy-bonding agent Akemi Akepox stone structural epoxy, and Limeworks.us Ecologic Natural Hydraulic Lime 3.5 (NHL), non-pigmented repair mortar.

RGA cleaned this marble pedestal tomb and stacked bases with no psi water and a soft, wet brush. Conservation work included the cleaning/treating all components with Orvus WA Paste (a non-ionic detergent) and D/2 Biological Solution to remove atmospheric staining and biological growth, respectively.

Each component (stacked bases and shaft) was lifted using a wood clamp system operated by two people.

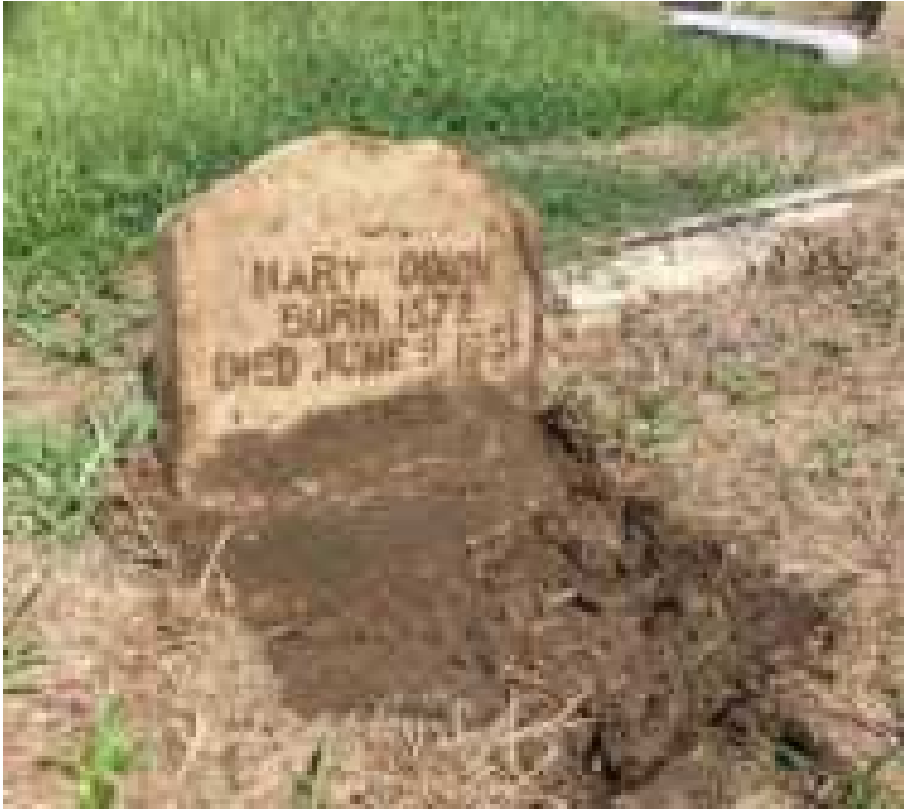
Conservation Treatment for Peter Dixon

Degraded, failed structural mortar was removed with small hand tools such as stone and wood chisels and metal mallets. The shaft and stacked bases were joined using lead wedges placed in each corner, small dabs of the epoxy-bonding agent Akemi Akepox stone structural epoxy, and Limeworks.us Ecologic Natural Hydraulic Lime 3.5 (NHL), non-pigmented repair mortar.

RGA cleaned this marble pedestal tomb and stacked bases with no psi water and a soft, wet brush. Conservation work included the cleaning/treating all components with Orvus WA Paste (a non-ionic detergent) and D/2 Biological Solution to remove atmospheric staining and biological growth, respectively.

RGA's conservation team relocated the stacked bases and broken shaft to area adjacent to the burial plot and place them on padded supports where they can be properly assessed and cleaned. The lowest base was leveled on a mixture of crushed rock and sand. Resetting/leveling requires excavating to the bottom of the gravemarker, straightening the base to vertical, backfilling and tamping the crushed rock and sand, and replacing and tamping the topsoil removed during excavation. The use of crushed rock and sand for leveling is preferential to concrete because concrete is much harder than the original stone type, and the mixture of crushed rock and sand helps maintain drainage away from the gravemarker.

Each component (stacked bases and shaft) was lifted using a wood clamp system operated by two people.

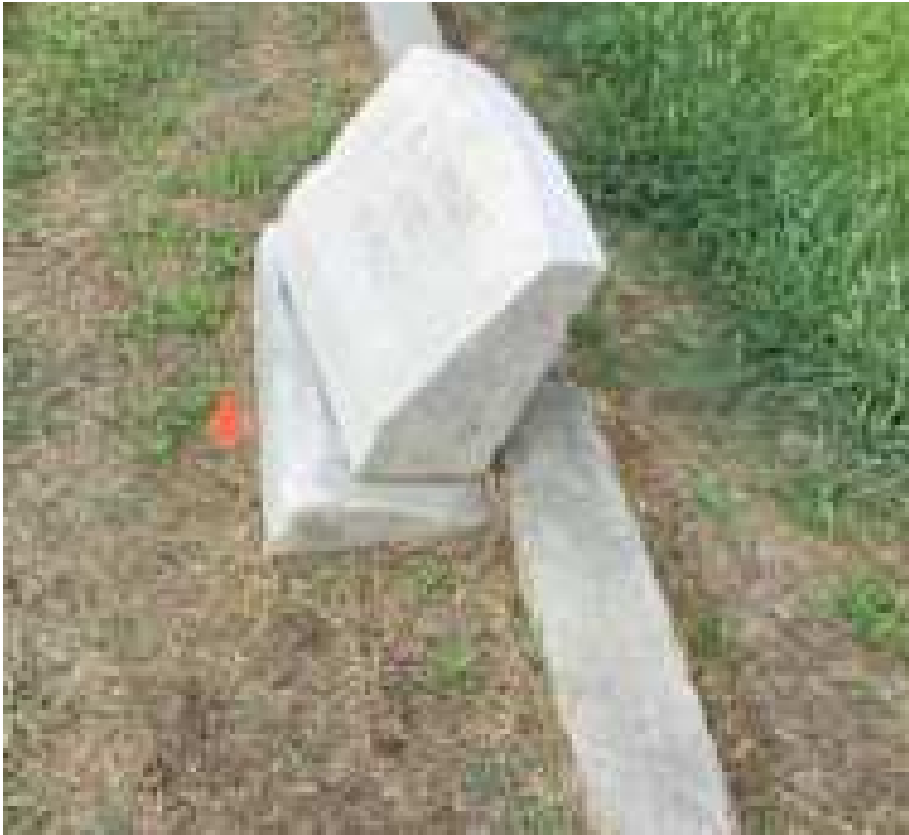
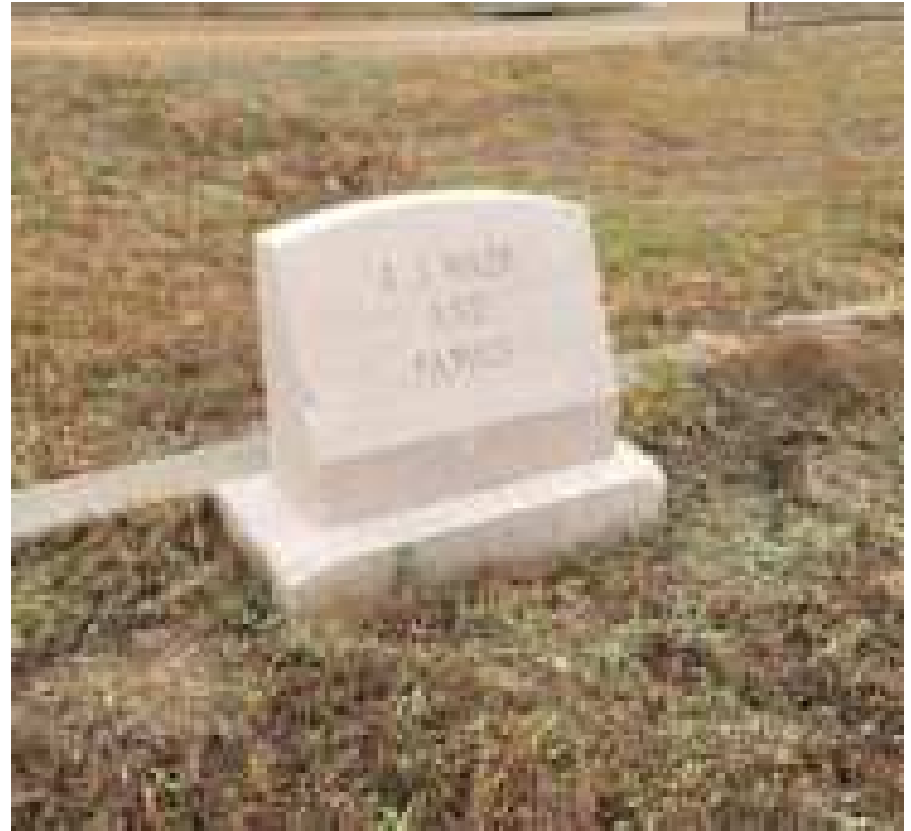
Conservation Treatment for Thomas Ware

The cementitious mortar joining the shaft and base is original.

RGA cleaned the marble pedestal tomb and stacked with no psi water and a soft, wet brush. Conservation work included the cleaning/treating of all components with Orvus WA Paste (a non-ionic detergent) and D/2 Biological Solution to remove atmospheric staining and biological growth, respectively.

RGA leveled the pedestal tomb on a mixture of crushed rock and sand. Resetting/leveling requires excavating to the bottom of the gravemarker, straightening the base to vertical, backfilling and tamping the crushed rock and sand, and replacing and tamping the topsoil removed during excavation. The use of crushed rock and sand for leveling is preferential to concrete because concrete is much harder than the original stone type, and the mixture of crushed rock and sand helps maintain drainage away from the gravemarker.

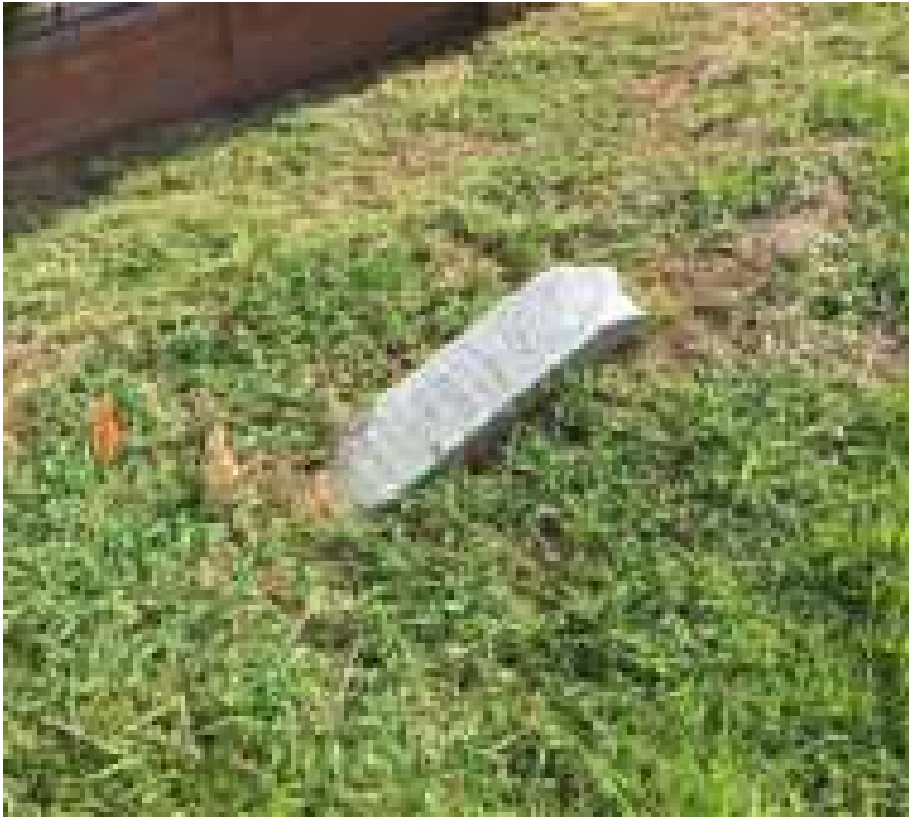
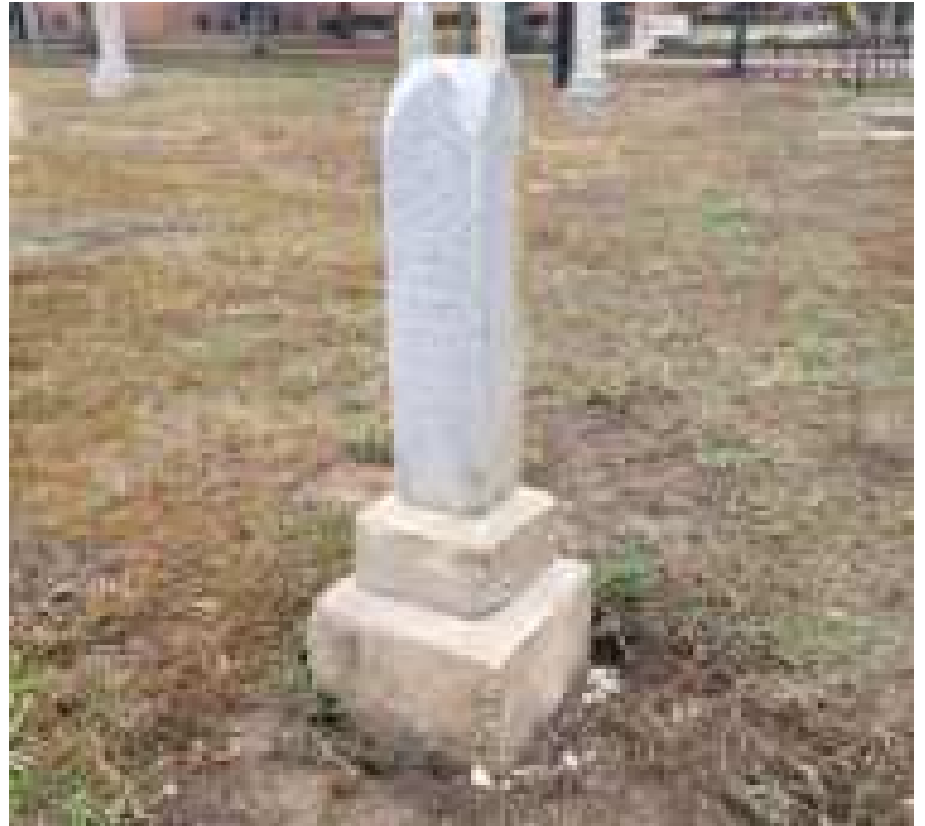
Conservation Treatment for W. Greene

Degraded, failed structural mortar was removed with small hand tools such as stone and wood chisels and metal mallets. The shaft and stacked bases were joined using lead wedges placed in each corner, small dabs of the epoxy-bonding agent Akemi Akepox stone structural epoxy, and Limeworks.us Ecologic Natural Hydraulic Lime 3.5 (NHL), non-pigmented repair mortar. RGA staff used the lime repair mortar to "built out" large deteriorated section of the upper base and shaft.

RGA cleaned the gravemarker with no psi water and a soft, wet brush. RGA utilized Orvus WA Paste (a non-ionic detergent) and D/2 Biological Solution to remove atmospheric staining and biological growth, respectively.

Each component (stacked bases and shaft) was lifted using a wood clamp system operated by two people.

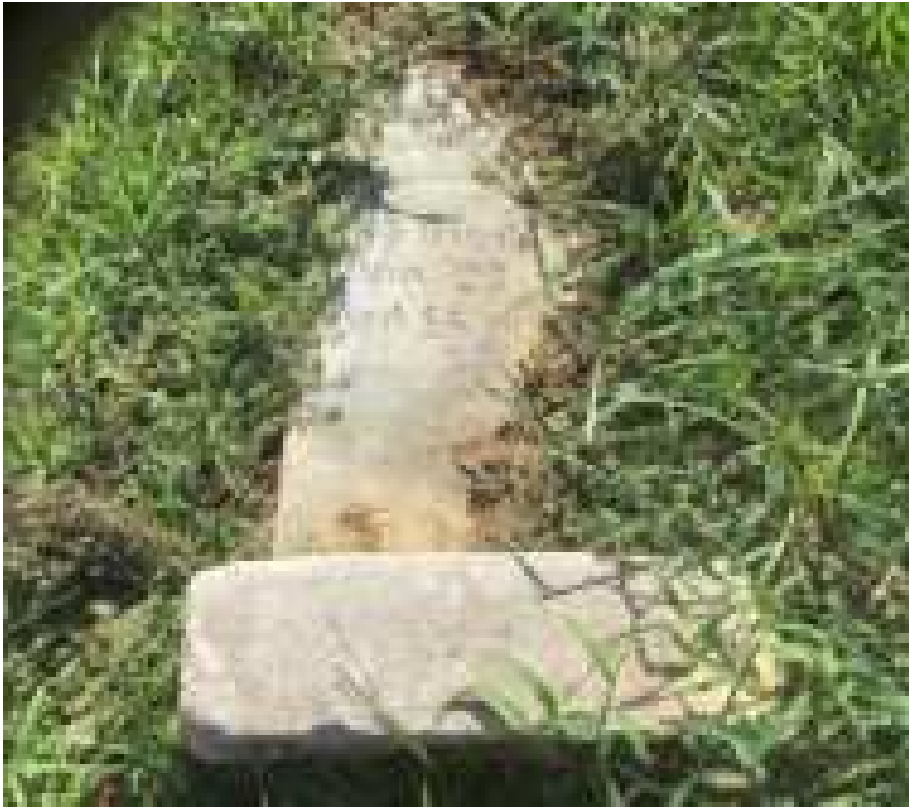
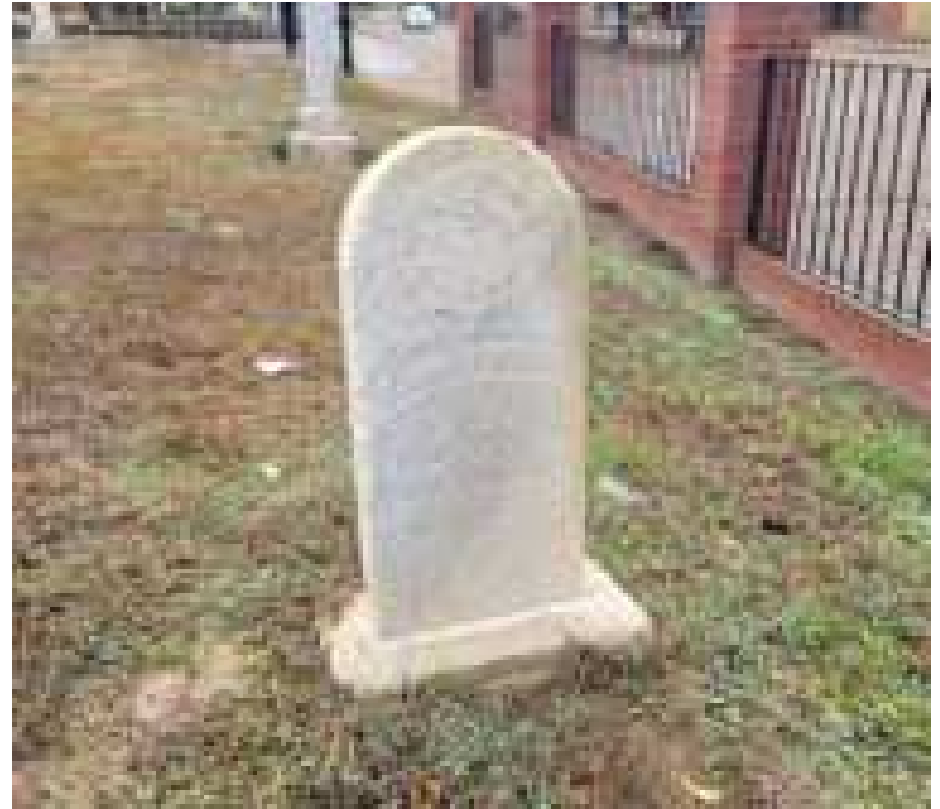
Conservation Treatment for Adam Lyles

Degraded, failed structural mortar was removed with small hand tools such as stone and wood chisels and metal mallets. The shaft and stacked bases were joined using lead wedges placed in each corner, small dabs of the epoxy-bonding agent Akemi Akepox stone structural epoxy, and Limeworks.us Ecologic Natural Hydraulic Lime 3.5 (NHL), non-pigmented repair mortar.

RGA cleaned the gravemarker with no psi water and a soft, wet brush. RGA utilized Orvus WA Paste (a non-ionic detergent) and D/2 Biological Solution to remove atmospheric staining and biological growth, respectively.

Each component (stacked bases and shaft) was lifted using a wood clamp system operated by two people.

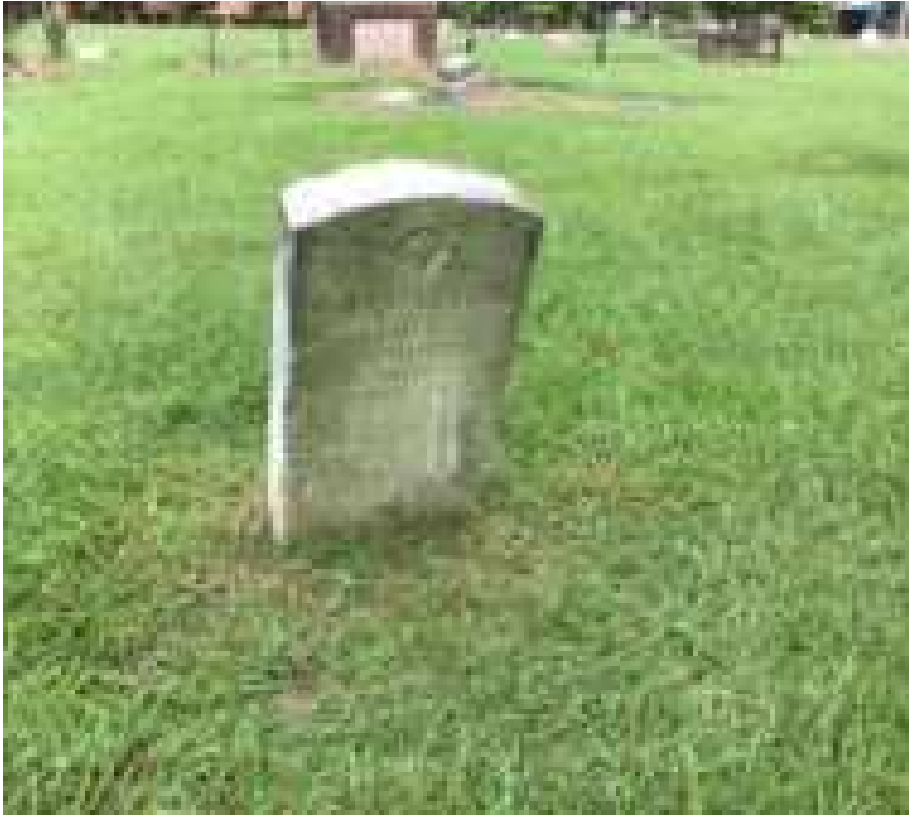
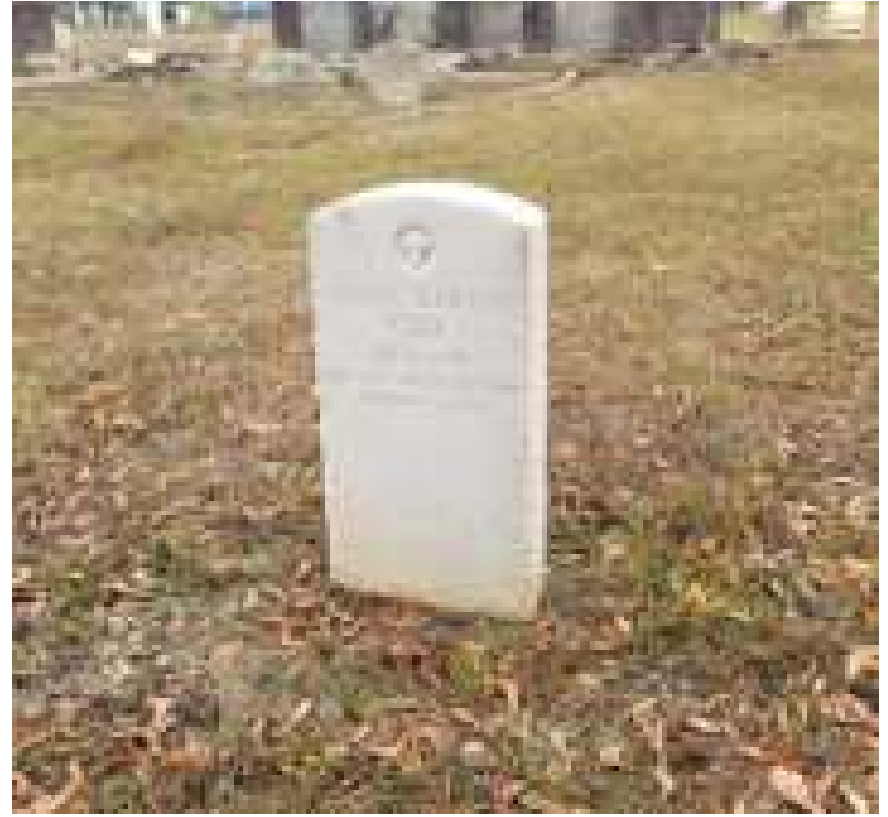
Conservation Treatment for R.S. Poston

The marble tablet was secure in the socketed base and did not require any treatments.

RGA's conservation team leveled the marker with a mixture of crushed rock and sand. Resetting/leveling involved setting it on a compacted bed of crushed rock and sand, backfilling, and tamping the crushed rock and sand, and replacing and tamping the topsoil removed during excavation. The use of crushed rock and sand for leveling is preferential to concrete because concrete is much harder than the original stone type, and the mixture of crushed rock and sand helps maintain drainage away from the gravemarker.

RGA cleaned the marker with no psi water and a soft, wet brush. Conservation work included the cleaning/treating of both the with Orvus WA Paste (a non-ionic detergent) and D/2 Biological Solution to remove atmospheric staining and biological growth, respectively. Once treated, RGA used plastic paint scrapers, brushes with Tampico or nylon bristles, and soft toothbrushes to remove staining and biological growth.

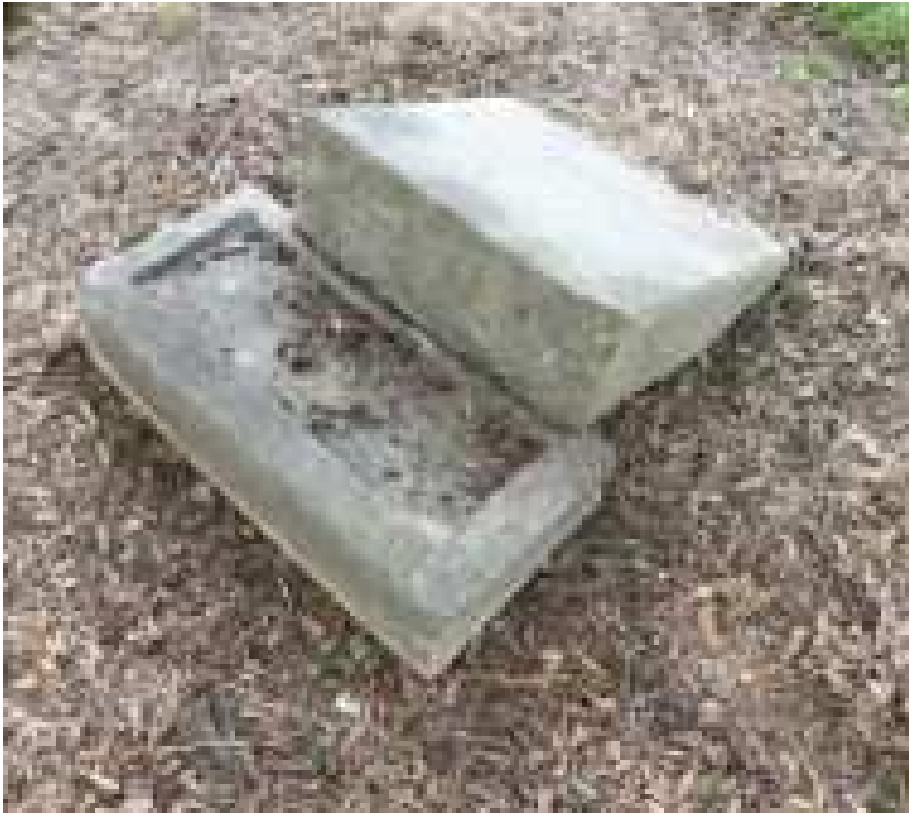
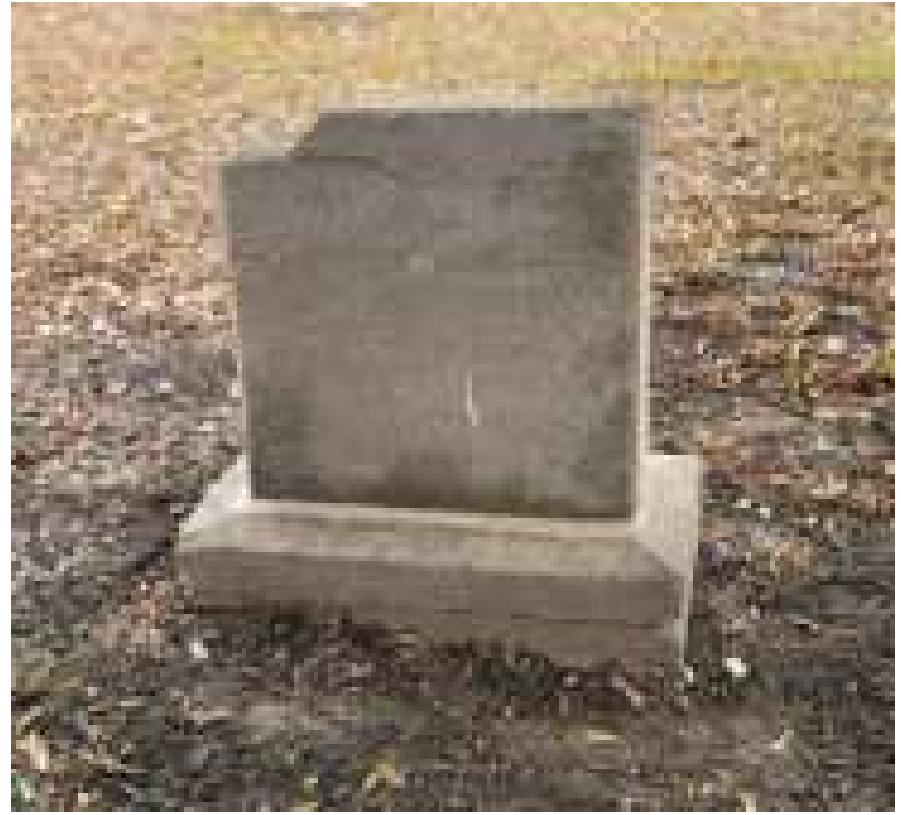
Conservation Treatment for Charles Shaw

The shaft and upper base were lifted using a wood clamp system operated by two people. Concrete had previously been poured around the lower base and was not movable.

RGA cleaned the gravemarker with no psi water and a soft, wet brush. RGA utilized Orvus WA Paste (a non-ionic detergent) and D/2 Biological Solution to remove atmospheric staining and biological growth, respectively.

Degraded, failed structural mortar was removed with small hand tools such as stone and wood chisels and metal mallets. The shaft and stacked bases were joined using lead wedges placed in each corner, small dabs of the epoxy-bonding agent Akemi Akepox stone structural epoxy, and Limeworks.us Ecologic Natural Hydraulic Lime 3.5 (NHL), non-pigmented repair mortar.

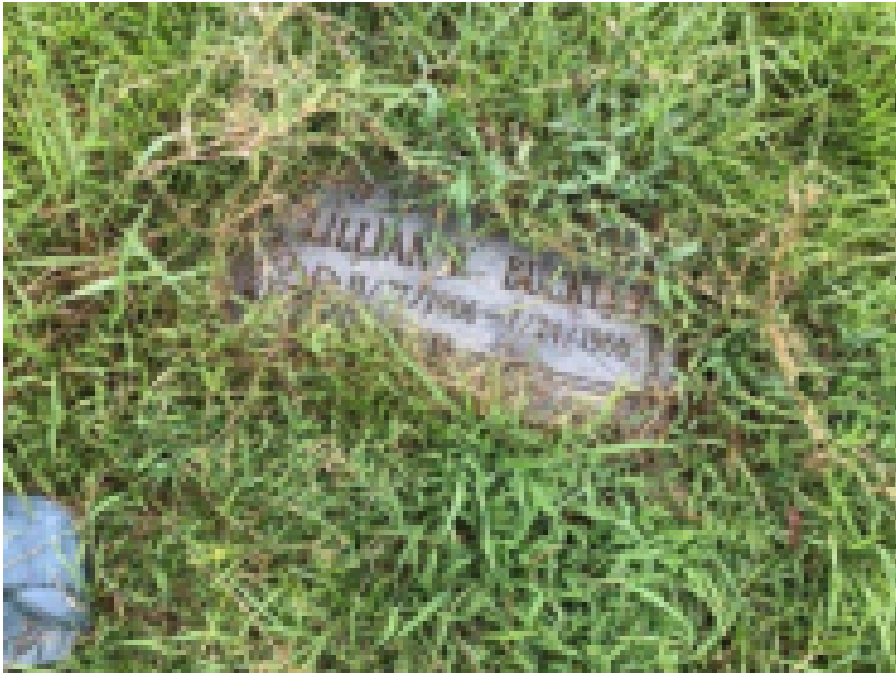
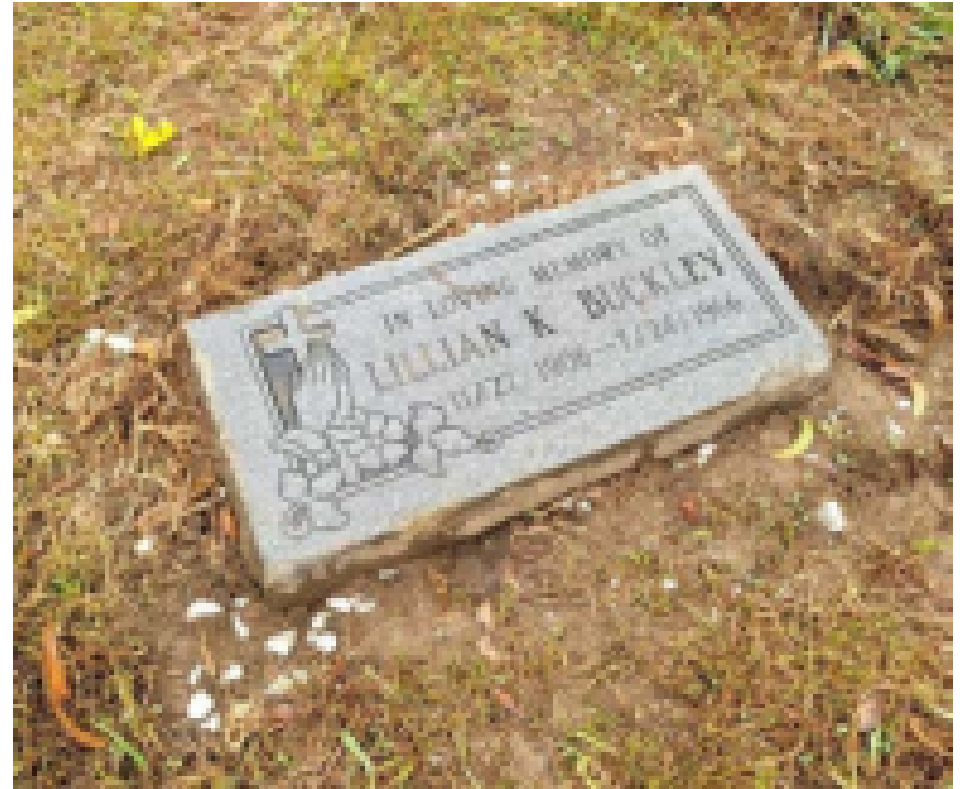
Conservation Treatment for

The shaft was displaced behind a mausoleum, and the stacked bases were in front of the mausoleum. RGA cleaned the shaft and stacked bases with no psi water and a soft, wet brush. RGA utilized Orvus WA Paste (a non-ionic detergent) and D/2 Biological Solution to remove atmospheric staining and biological growth, respectively.

Degraded, failed structural mortar was removed with small hand tools such as stone and wood chisels and metal mallets. The shaft and stacked bases were joined using lead wedges placed in each corner, small dabs of the epoxy-bonding agent Akemi Akepo stone structural epoxy, and Limeworks.us Ecologic Natural Hydraulic Lime 3.5 (NHL), non-pigmented repair mortar.

Each component (stacked bases and shaft) was lifted using a wood clamp system operated by two people.

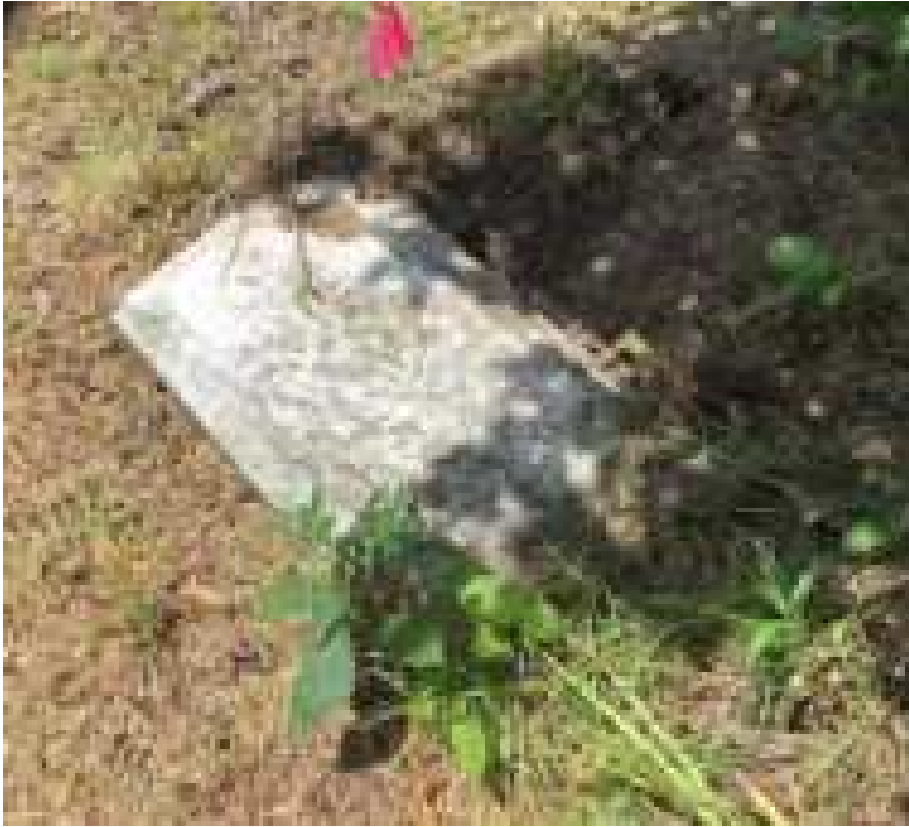
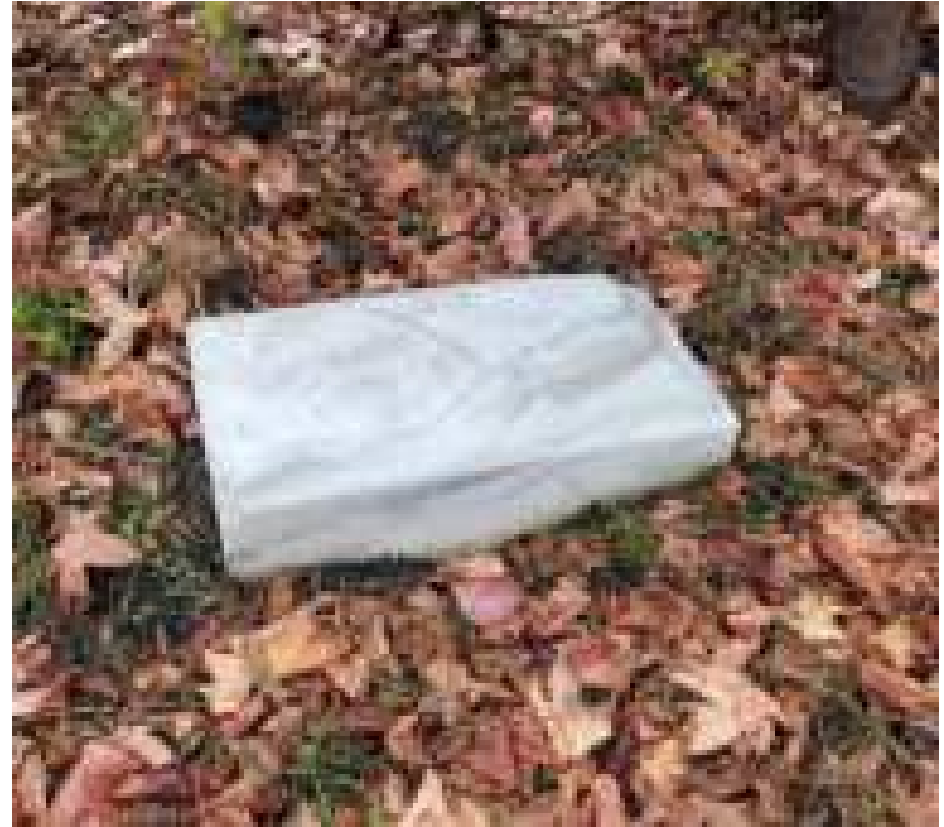
Conservation Treatment

The upper section of the gravemarker was not located during fieldwork.

RGA's conservation team leveled the marble base with a mixture of crushed rock and sand. Resetting/leveling involved setting it on a compacted bed of crushed rock and sand, backfilling, and tamping the crushed rock and sand, and replacing and tamping the topsoil removed during excavation. The use of crushed rock and sand for leveling is preferential to concrete because concrete is much harder than the original stone type, and the mixture of crushed rock and sand helps maintain drainage away from the gravemarker.

RGA cleaned the base with no psi water and a soft, wet brush. Conservation work included the cleaning/treating of both the with Orvus WA Paste (a non-ionic detergent) and D/2 Biological Solution to remove atmospheric staining and biological growth, respectively. Once treated, RGA used plastic paint scrapers, brushes with Tampico or nylon bristles, and soft toothbrushes to remove staining and biological growth.

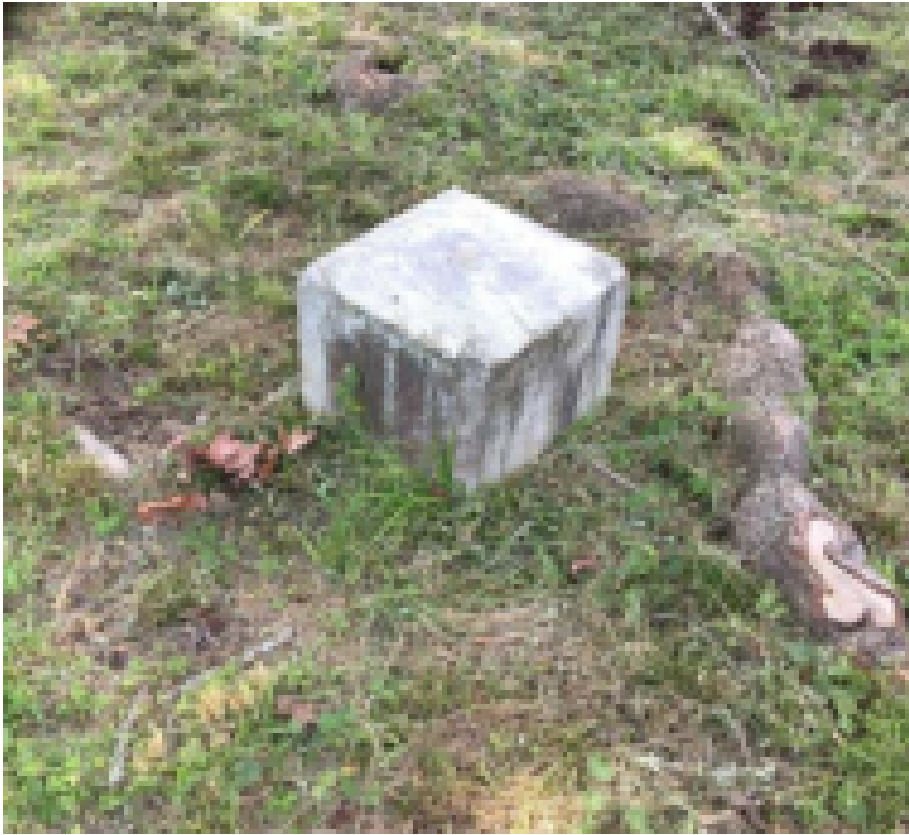
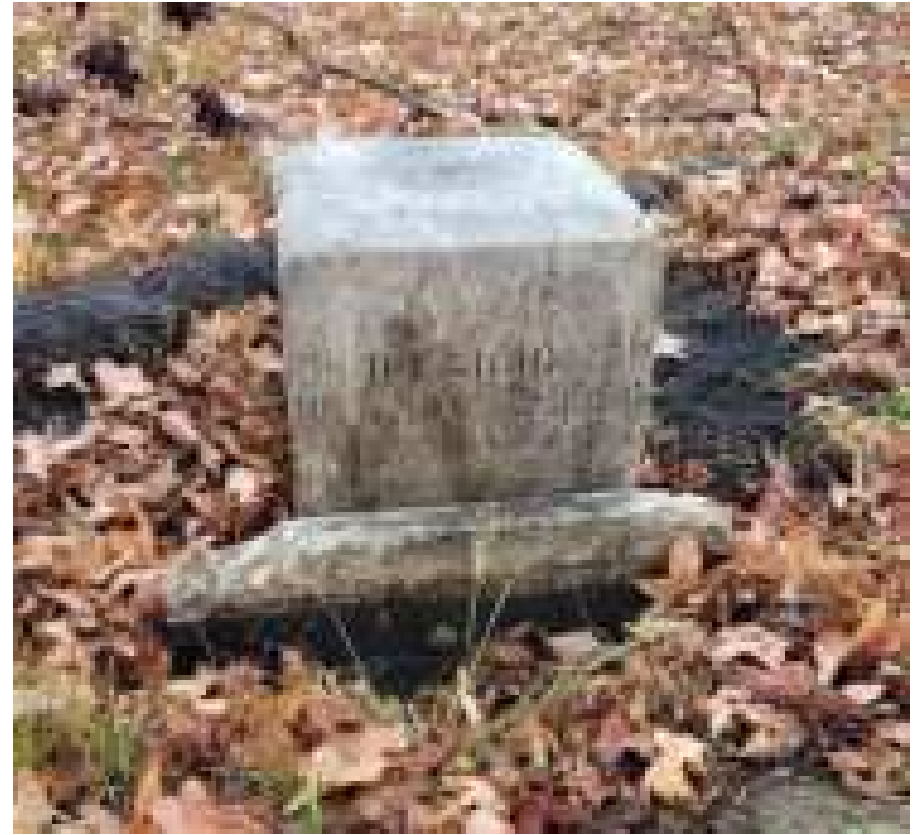
Conservation Treatment for Dr. D.K. Johnson

The gravemarker's upper section was not located during fieldwork.

RGA cleaned the marble gravemarker with no psi water and a soft, wet brush. Conservation work included the cleaning/treating the gravemarker with Orvus WA Paste (a non-ionic detergent) and D/2 Biological Solution to remove atmospheric staining and biological growth, respectively.

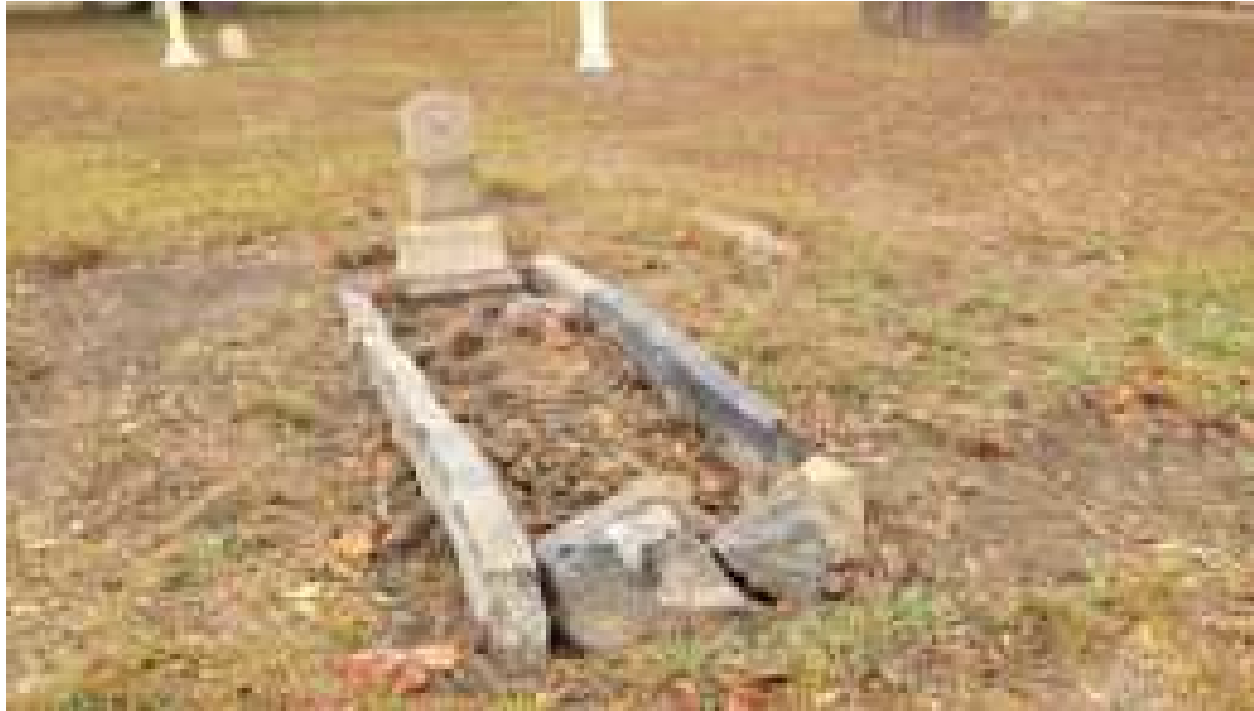
Conservation Treatment

While excavating the base, RGA staff uncovered the concrete tablet, and granite plot enclosure.

RGA cleaned the marker and plot enclosure with no psi water and a soft, wet brush. Conservation work included the cleaning/treating of both the with Orvus WA Paste (a non-ionic detergent) and D/2 Biological Solution to remove atmospheric staining and biological growth, respectively. Once treated, RGA used plastic paint scrapers, brushes with Tampico or nylon bristles, and soft toothbrushes to remove staining and biological growth.

The two broken pieces of the tablet were joined with small dabs of the epoxy-bonding agent Akemi Akepox stone structural epoxy, and Limeworks.us St. Astier Lithomex Ecologic Stone Patching Mortar.
